European Flood Awareness System

DETAILED ASSESSMENT REPORT

EFAS DISSEMINATION CENTRE

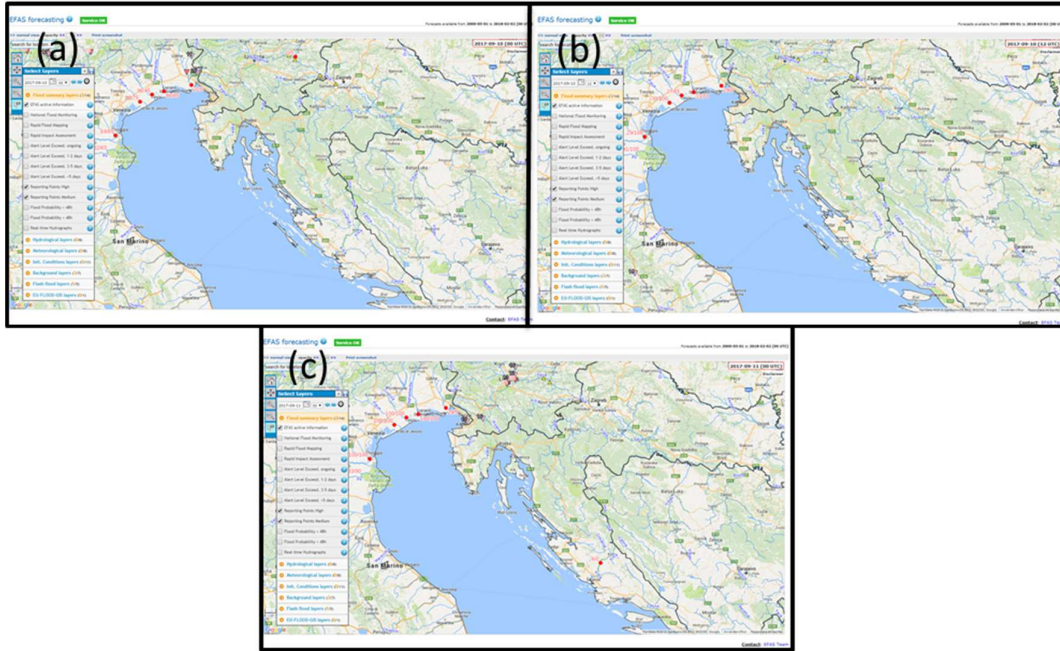
Figure 10. The forecasts for flash flooding on (a-b) September 10th 00.00 and 12.00 UTC respectively, and (c) September 11th 00.00 UTC.

The intense precipitation that fell between the 11th and 12th September in Zadar area was not forecasted in the EFAS-IS (Figure 10). This is probably due to the inadequate COSMO-LEPS based precipitation forecasts which did not predict sufficient precipitation volume to generate flash floods. It seems that even the 65 mm of precipitation during this one day, as forecasted in COSMO-LEPS, were not sufficient to exceed the ERIC indicator thresholds. The spatial distribution of the precipitation event is another factor for this miss of flash flood; the event had a very local character as this was a typical convective storm which current NWP models have difficulties in capturing.

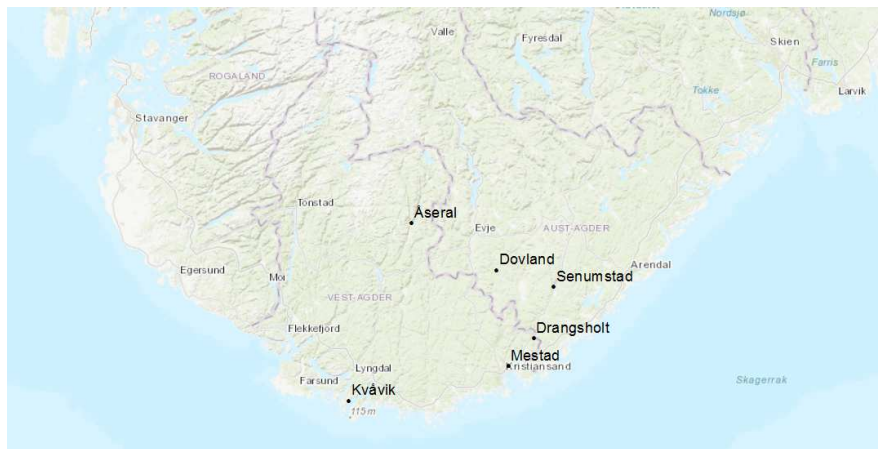
Figure 13. Map showing the location of referred precipitation stations in the affected area.

From September 30th to October 2nd as much as 281.8 mm precipitation fell in Senumstad, a village in Aust-Agder county (Figure 13). Nearly as much precipitation as in Senumstad fell in Mestad in Oddernes in Vest-Agder close to Kristiansand. In three days 280.6 mm was observed in Mestad. The precipitation in these two places had a return period of more than 100 years. Other stations where the precipitation had a return period of more than 100 years were Åseral with 280 mm in 3 days and Kvåvik with 226.4 mm in 3 days. These are situated in Vest-Agder. In Aust-Agder also another station had a precipitation of more than 100 years return period. This was in Dovland where 226.4 mm was observed in three days. More than 200 mm precipitation in three days was observed in 13 stations mainly covering the southern halves of the counties Aust-Agder and Vest-Agder (Ref: "Flommen på Sørlandet 30.9 – 3.10.2017" by NVE). The stations mentioned above are located in the same area as the flash flood reporting points in EFAS-IS.

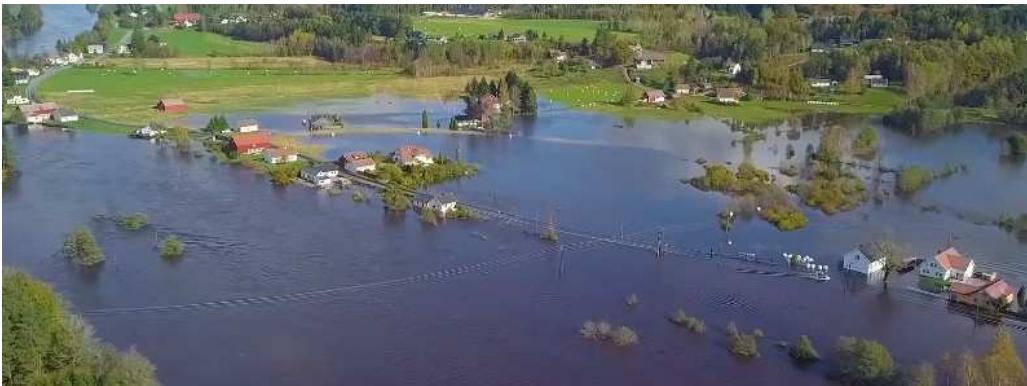
Photo 2. Drangsholt as posted by [Nikola Pajtic](#)¹⁹ on October 04, 2017. (The photo is published with permission by photographer Sten Arne Brunsby).

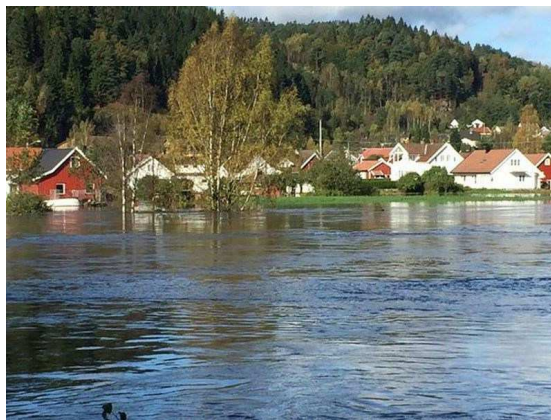
Photo 3. Flooded area in Sørlandet.
